**QUALITY ASSURANCE TEST OF A
THIOKOL CHEMICAL CORPORATION TE-M-364-3
SOLID-PROPELLANT ROCKET MOTOR
TESTED IN THE SPIN MODE
AT SIMULATED ALTITUDE CONDITIONS**

**ENGINE TEST FACILITY
ARNOLD ENGINEERING DEVELOPMENT CENTER
AIR FORCE SYSTEMS COMMAND
ARNOLD AIR FORCE STATION, TENNESSEE**

H. L. Merryman and R. M. Brooksbank
ARO, Inc.

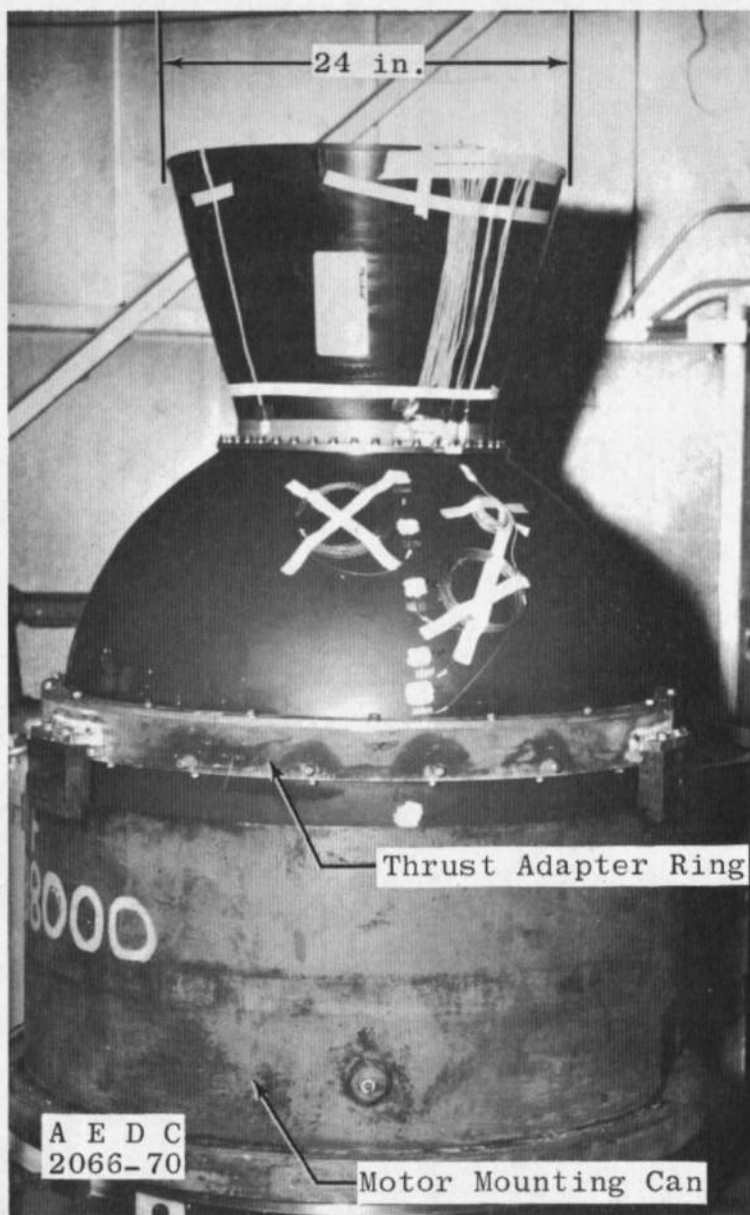
c. Photograph (Motor Installed in Mounting Can)

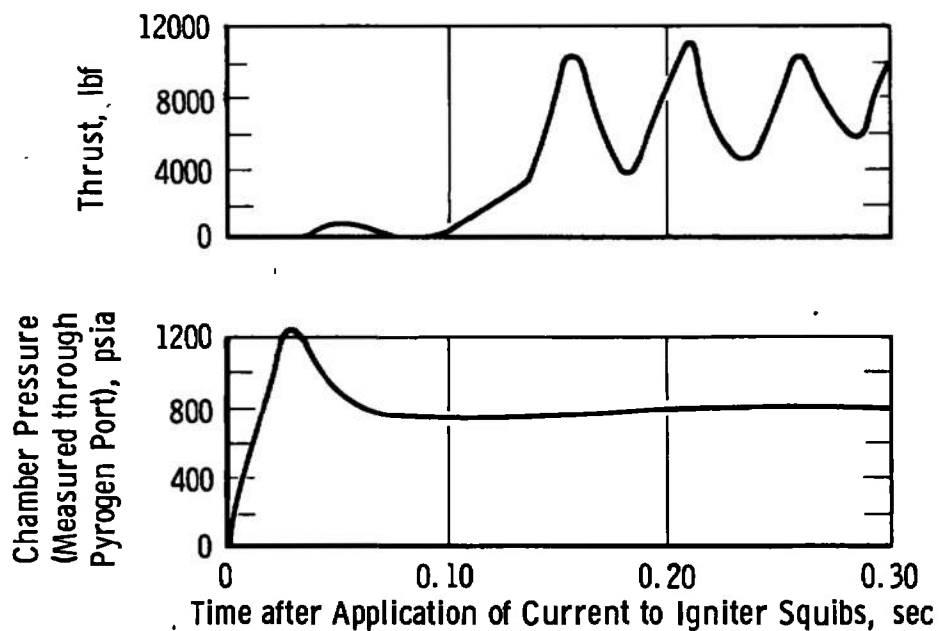
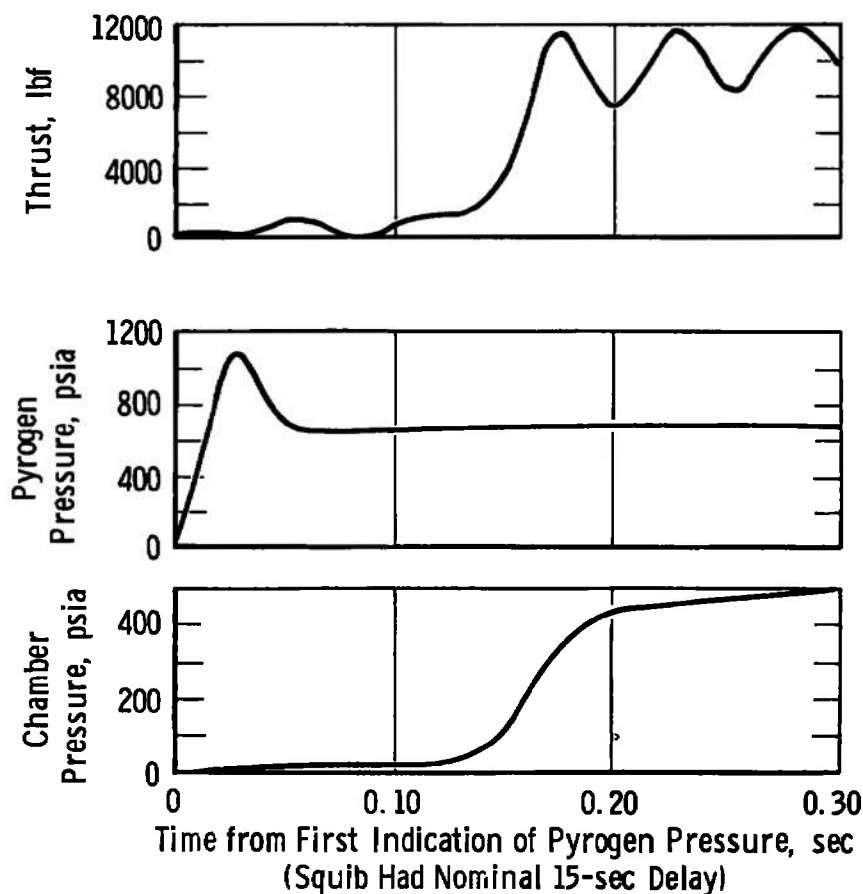
a. Motor S/N 00010

b. Typical Motor from Ref. 2

Fig. 6 Variation of Thrust and Chamber Pressure during the Motor Ignition Event

The motor was ignited at a pressure altitude of 111,000 ft. Variation of thrust and chamber pressure during the ignition event is shown in Fig. 6. Also shown (Fig. 6b) is a typical ignition event from Ref. 2. These figures are shown for comparison since the chamber pressures reported herein were measured through the Pyrogen pressure port. The igniter for the motor reported herein incorporated two Hi-Shear PC-37-03 short delay squibs. The igniters for the motors previously tested (Refs. 1 and 2) incorporated McCormick-Selph squibs (nominal 15-sec delay).

The ignition lag time (t_l) for the motor reported herein was 0.001 sec. This value cannot be directly compared with the t_l values presented in Refs. 1 and 2 because of the differences in squib types and location of the chamber pressure measuring ports. However, the comparison of Figs. 6a and b shows that thrust increased at about the same time after the first indication of Pyrogen pressure (chamber pressure for the motor herein), and it is, therefore, concluded that the ignition event of motor S/N 00010 agreed closely with the ignition events presented in Refs. 1 and 2.

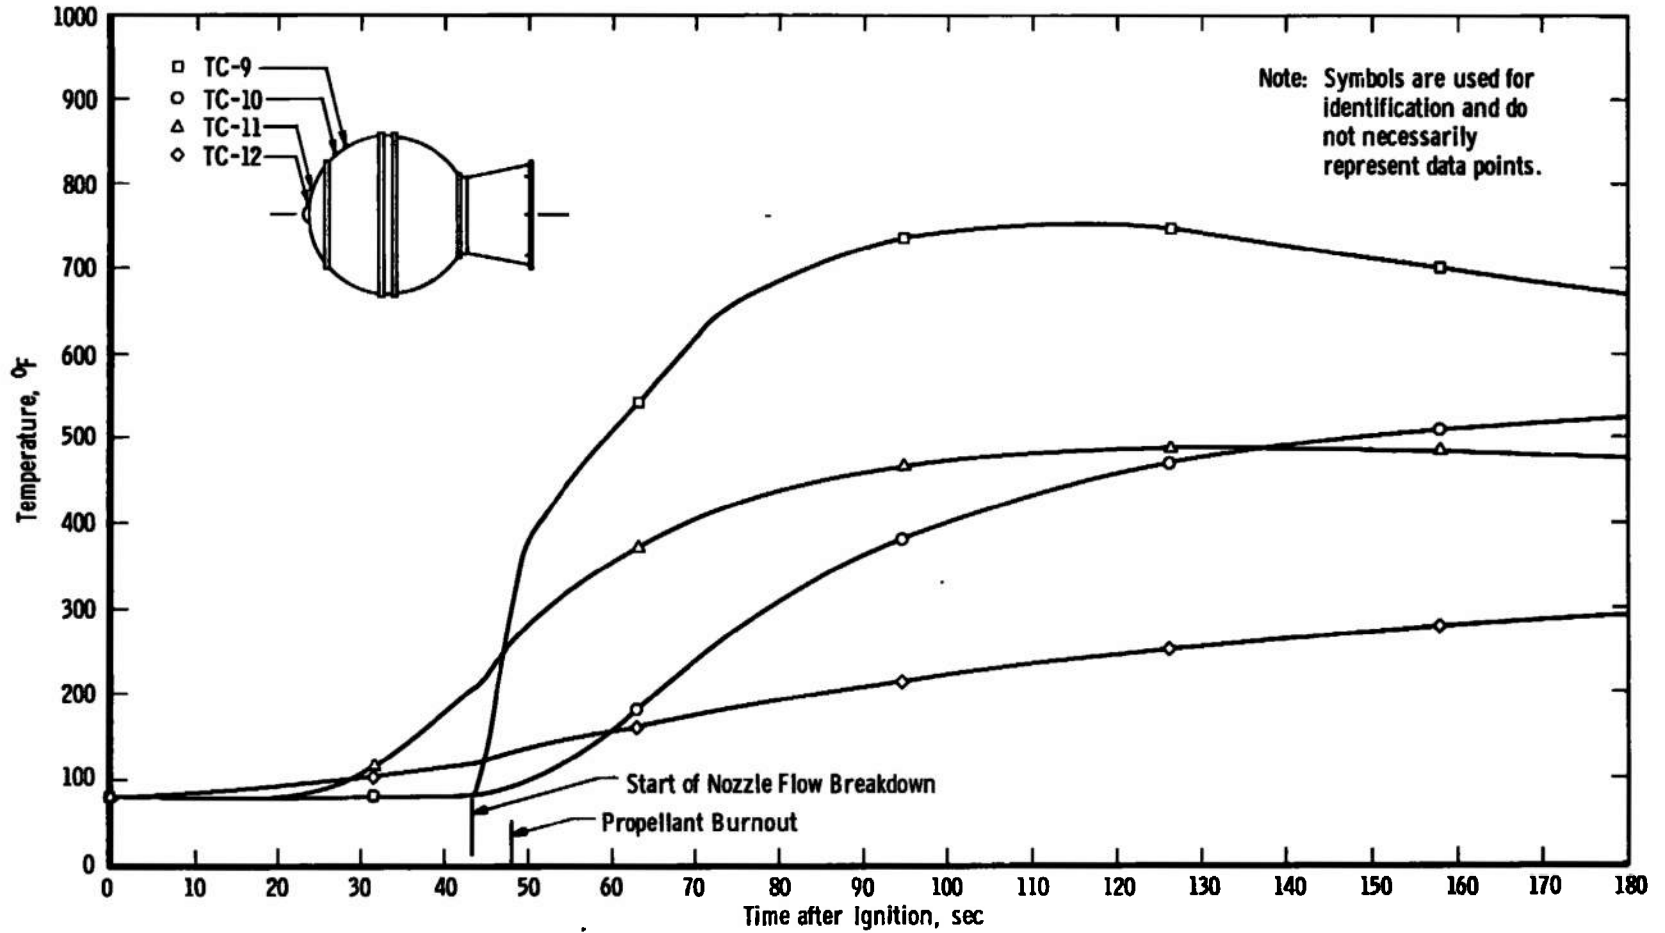
a. Forward Hemisphere (TC-9, TC-10, TC-11, TC-12)
Fig. 11 Time Variation of Motor Case Temperatures

b. Aft Hemisphere (TC-1, TC-2, TC-3, TC-4)
Fig. 11 Continued

c. Midsection (TC-5, TC-7, TC-8)
Fig. 11 Continued

d. Nozzle Adapter Flange (0 deg) (TC-13, TC-14, TC-18, TC-19)

e. Nozzle Adapter Flange (180 deg) (TC-15, TC-16, TC-20, TC-22)

f. Nozzle (0 deg) (TC-17, TC-21, TC-24)

Motor case and nozzle temperatures are presented in Fig. 11. The maximum case temperature was 747°F and occurred approximately 115 sec after motor ignition at thermocouple TC-9 (Fig. 11a) located at the junction of the insulated and uninsulated portion of the forward hemisphere over a propellant peak. The motor qualification specification (Ref. 4) states that the temperature of the motor case external surface shall not exceed 500°F at any time from ignition to 150 sec thereafter. However, maximum temperature was nominal for the TE-M-364-3 motors fired to date. The maximum nozzle temperature was 711°F and occurred approximately 50 sec after motor ignition at thermocouple TC-21 (Fig. 11f) located approximately 1 in. forward of the exit plane.

6. The maximum measured case temperature was 747°F, occurring approximately 115 sec after ignition at an area on the forward hemisphere between the insulated and uninsulated portion of the case. This temperature exceeds the 500°F maximum specified in the motor qualification specification.

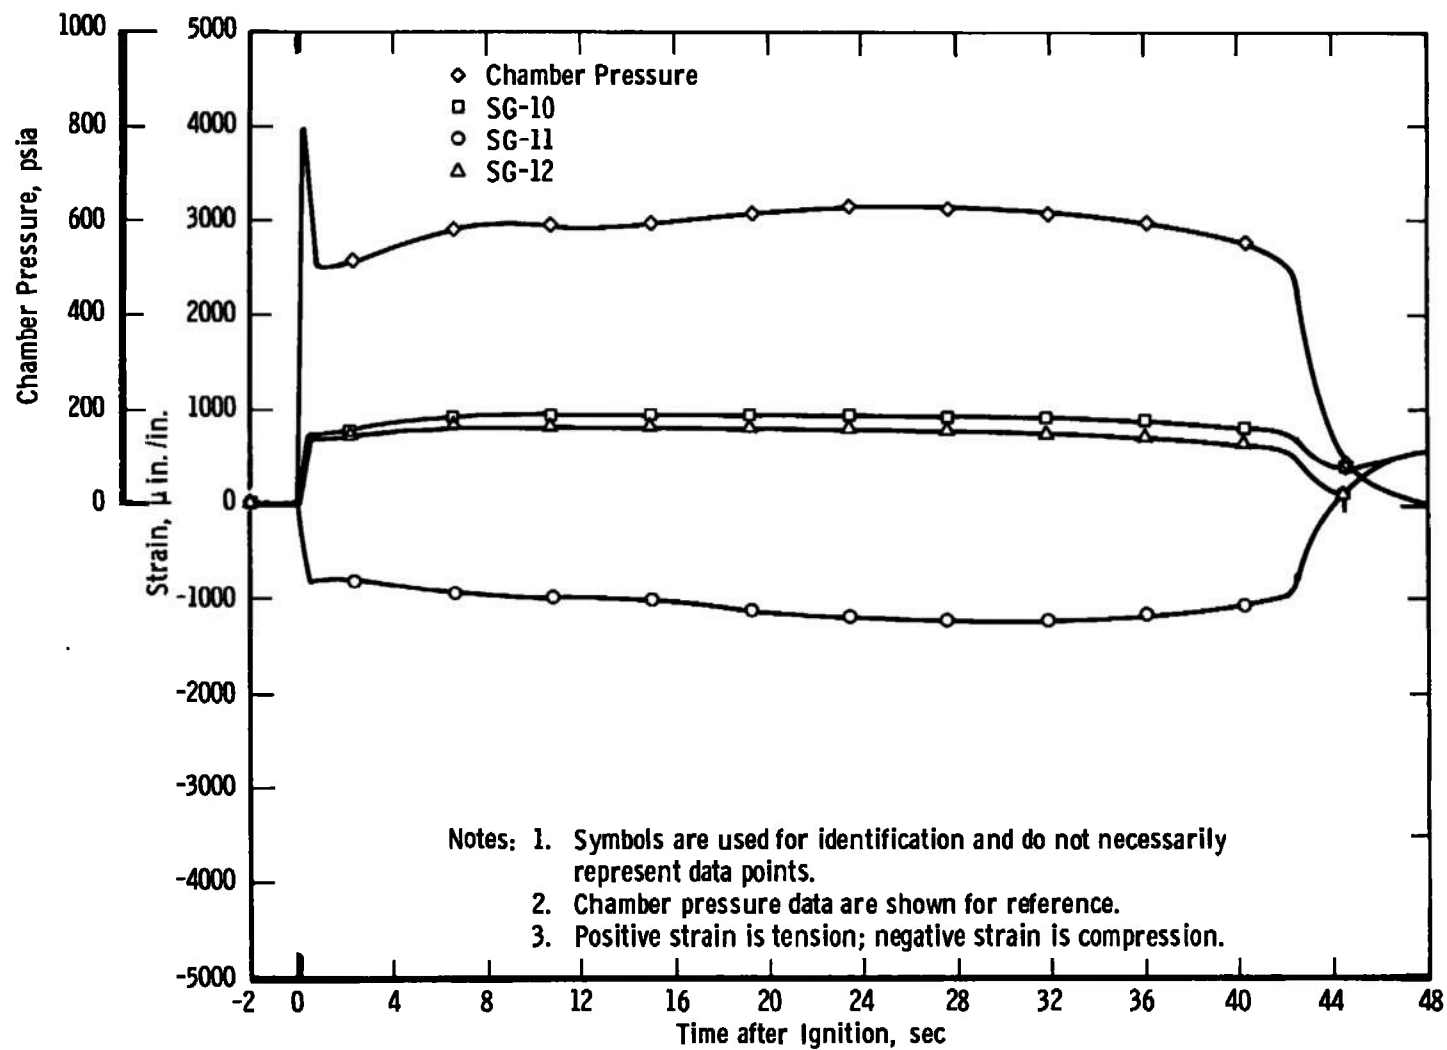
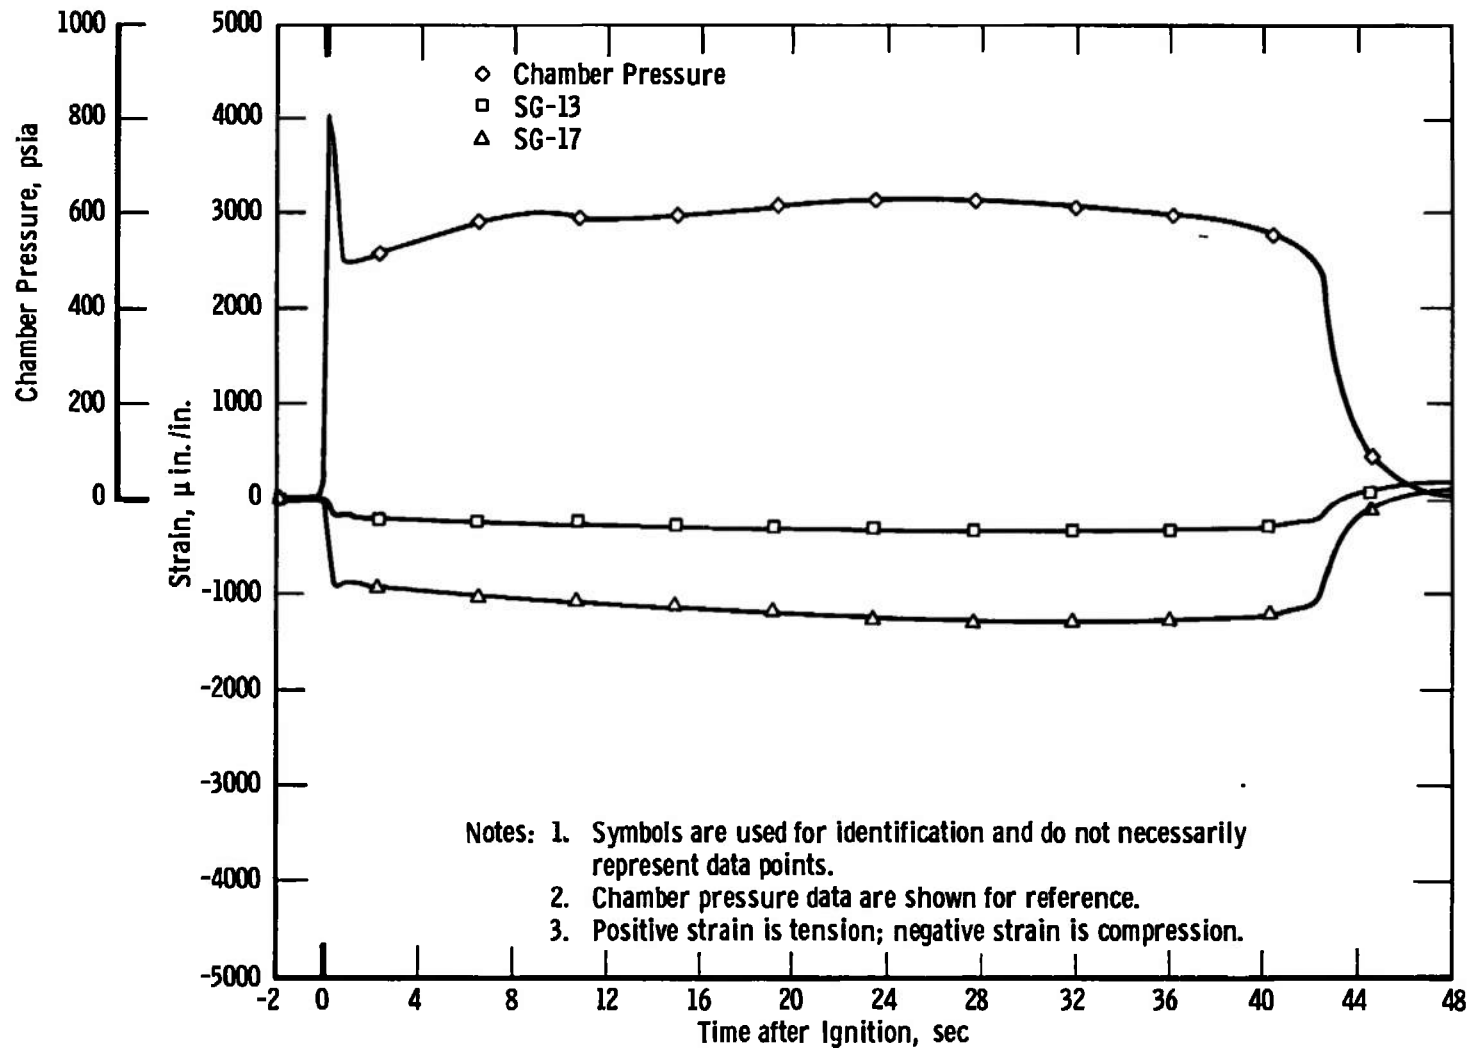
a. Flange (0 deg), Triaxial (SG-1, SG-2, SG-3)

Fig. 12 Case and Nozzle Adapter Flange Strain Variation with Time

b. Flange (180 deg), Triaxial (SG-4, SG-5, SG-6)
Fig. 12 Continued

c. Flange (90 deg), Triaxial (SG-7, SG-8, SG-9)

d. Flange (270 deg), Triaxial (SG-10, SG-11, SG-12)

e. Flange (0 deg), Longitudinal (SG-13, SG-17)
Fig. 12 Continued

Motor case and nozzle flange strain data are presented in Fig. 12. The maximum strain level measured was 4500 μ in./in. (tension) and occurred approximately 26 sec after motor ignition at grid SG-45 (Fig. 12o),

Two, triaxial flight-type strain grids supplied by McDonnell-Douglas were located at circumferential locations of 0 and 180 deg (Fig. 5b). Strain levels, as measured by these grids, were in good agreement with the strain levels obtained from the Thiokol-supplied (commercial-grade) triaxial grids located at 90 and 270 deg. Analysis of the biaxial grid data revealed that the maximum hoop strain levels were relatively constant ($\sim 2600 \mu\text{in./in.}$ tension), whereas the maximum longitudinal strain levels increased from about $1000 \mu\text{in./in.}$ (compression) on the ID of the flange to $3500 \mu\text{in./in.}$ at the OD. All strain grids were installed by Thiokol Representatives using Eastman 910® adhesive.
